**Vacant Rental Program (VRP)**

**Bid Documentation Packet**

**Project: 1408 Main Street Niagara Falls, New York 14305**

## 1408 Main Street – APT 1

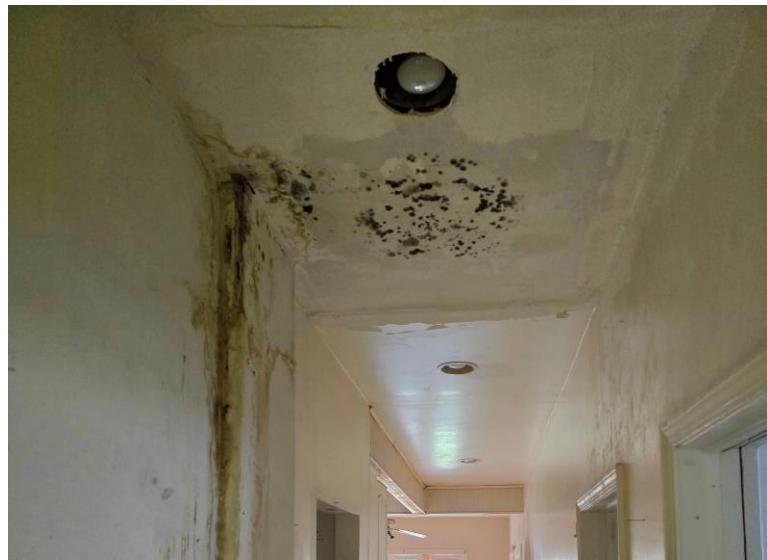
The unit was vacant at the time of inspection. Water damage and visible mold were noted on the ceiling (approximately 48 square feet) and wall D of the entry hall (approximately 8 linear feet of wall terminating at doorway to Laundry Room). The source of moisture was reported to be a roof leak which has been repaired.

Mold on Entry Hall ceiling

Visible mold was observed on the Entrance Hall ceiling and D-Wall impacting approximately 120 square feet of drywall.

Per EPA 402-K-02-003, and other published guidelines, it is generally not recommended the Client self-perform remediation of areas greater than 10 square feet of fungal growth. As the affected area exceeds this, it is recommended a remediation contractor perform this project. It is required in NYS that mold remediation work, when contracted, must be performed by a Mold Remediation Contractor licensed in the State of New York under article 32 of the NYS Labor Law, and performance of the work should be conducted in accordance with the Remediation Plan in section 5 of this document.

Upon completion of containment the affected drywall and any underlying insulation shall be removed. Fungal growth on joists and studs shall be cleaned utilizing HEPA vacuum and wiping with an EPA registered fungicide/fungistat. All 3-dimensional growth shall be removed. Visible staining shall be removed to the extent feasible by scrub pads, or lightly sanding.

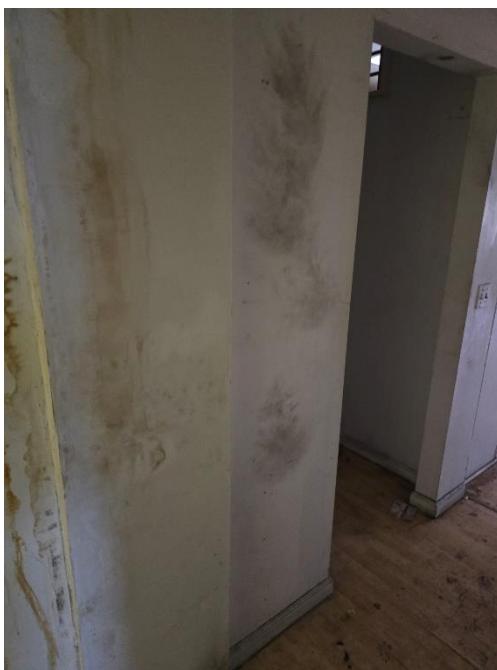
Mold and water damage on Entry Hall D Wall
