**Vacant Rental Program (VRP)**

**Bid Documentation Packet**

**Project: 1408 Main Street Niagara Falls, New York 14305**

**Apt :2**

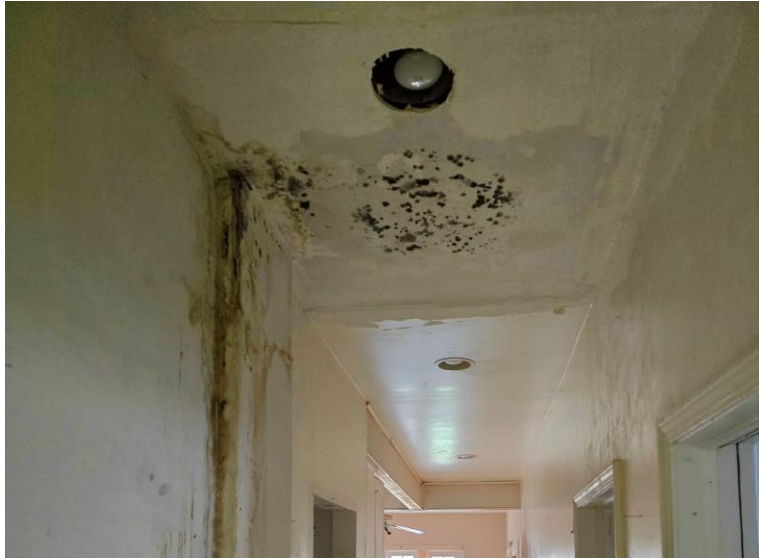
The unit was vacant at the time of inspection. Water damage and visible mold were noted on the ceiling (approximately 48 square feet) and wall D of the entry hall (approximately 8 linear feet of wall terminating at doorway to Laundry Room). The source of moisture was reported to be a roof leak which has been repaired.

Mold on Entry Hall ceiling

Per EPA 402-K-02-003, and other published guidelines, it is generally not recommended the Client self-perform remediation of areas greater than 10 square feet of fungal growth. As the affected area exceeds this, it is recommended a remediation contractor perform this project. It is required in NYS that mold remediation work, when contracted, must be performed by a Mold Remediation Contractor licensed in the State of New York under article 32 of the NYS Labor Law, and performance of the work should be conducted in accordance with the Remediation Plan in section 5 of this document.

Upon completion of containment the affected drywall and any underlying insulation shall be removed. Fungal growth on joists and studs shall be cleaned utilizing HEPA vacuum and wiping with an EPA registered fungicide/fungistat. All 3-dimensional growth shall be removed. Visible staining shall be removed to the extent feasible by scrub pads, or lightly sanding.

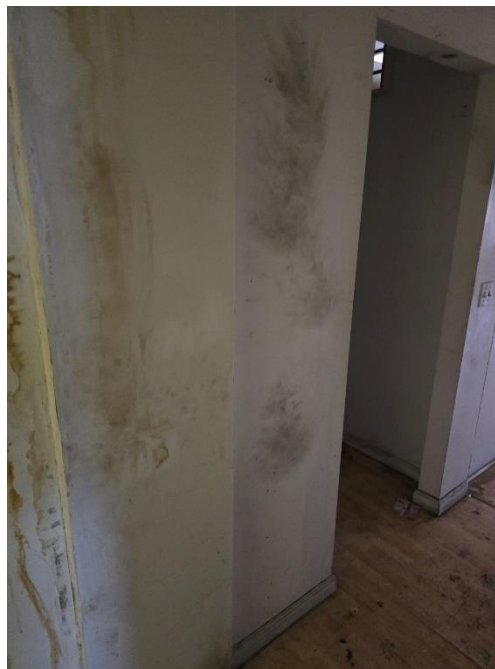
Mold and water damage on Entry Hall D Wall

Visible mold was observed on the Entrance Hall ceiling and D-Wall impacting approximately 120 square feet of drywall.
