**Vacant Rental Program (VRP)**

**Bid Documentation Packet**

**Project: 747 Pierce Avenue, Niagara Falls, New York 14305**

**Apt: Unit 1 Second Floor  
Front Apartment**

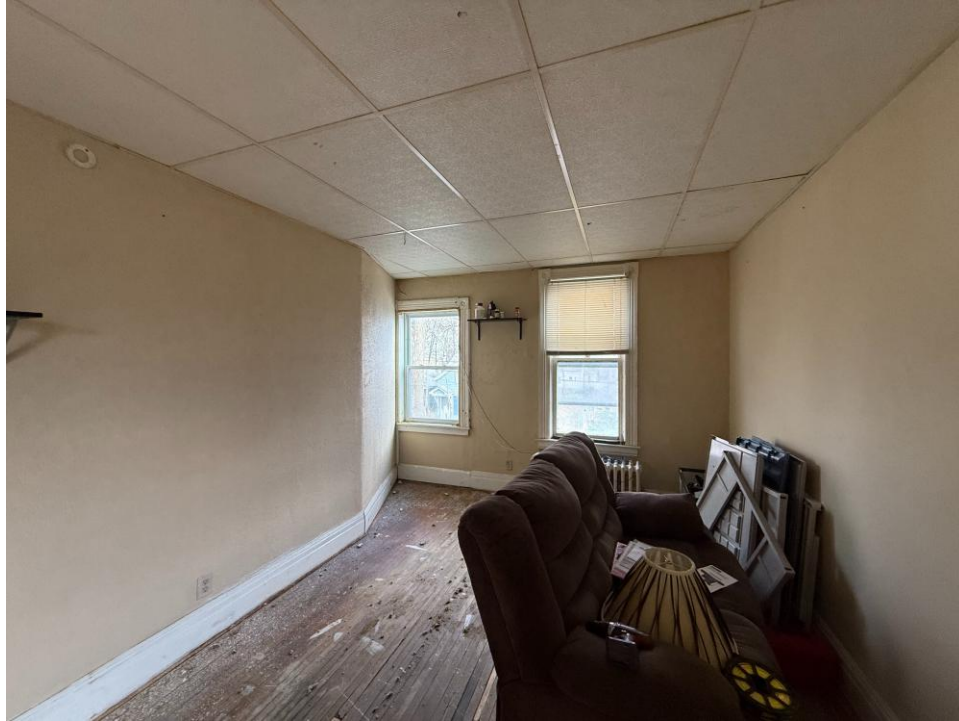
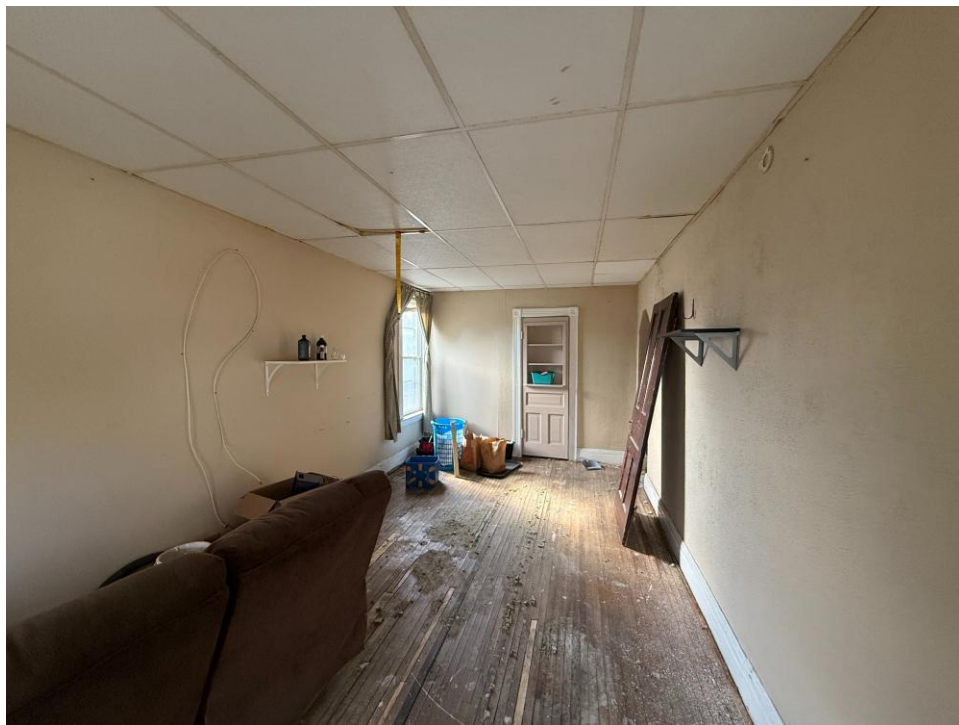
## 6. Bedroom

- Repair damaged plaster.
- Fill areas where lath is exposed.
- Patch all cracks, holes, and surface defects.
- Remove existing shelf located near ceiling.

- Paint walls Dove White, flat finish.
- Paint trim White, semi-gloss finish.
- Install new 1/4" luan underlayment.
- Install new glue-down luxury vinyl flooring.
- Install new ceiling light fixture.

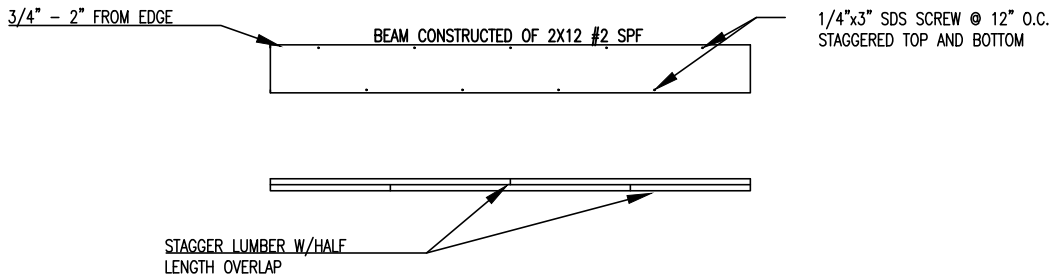
## BUILT UP BEAM DETAIL

On April 27, 2026, a structural inspection was conducted on the rear porch at **747 Pierce Ave., Niagara Falls, NY**. The porch is a three-level stacked structure. The existing column supports appear to be in acceptable condition; however, the built-up girder beams at each level are **undersized, improperly constructed, deteriorating, or exhibiting noticeable sagging**.

It is recommended that all girder beams be **replaced** with properly sized, built-up members consisting of **two (2) pressure-treated 2×12 #2 Southern Pine plies**, fastened together with nails or structural screws in accordance with **RCNYS 2025** requirements.
