**Vacant Rental Program (VRP)**

**Bid Documentation Packet**

**Project # Round 2 - #055**

**Project: 1029 Fairfield Avenue, Niagara Falls, New York  
14305 Unit:1 & 2 Side by Side**

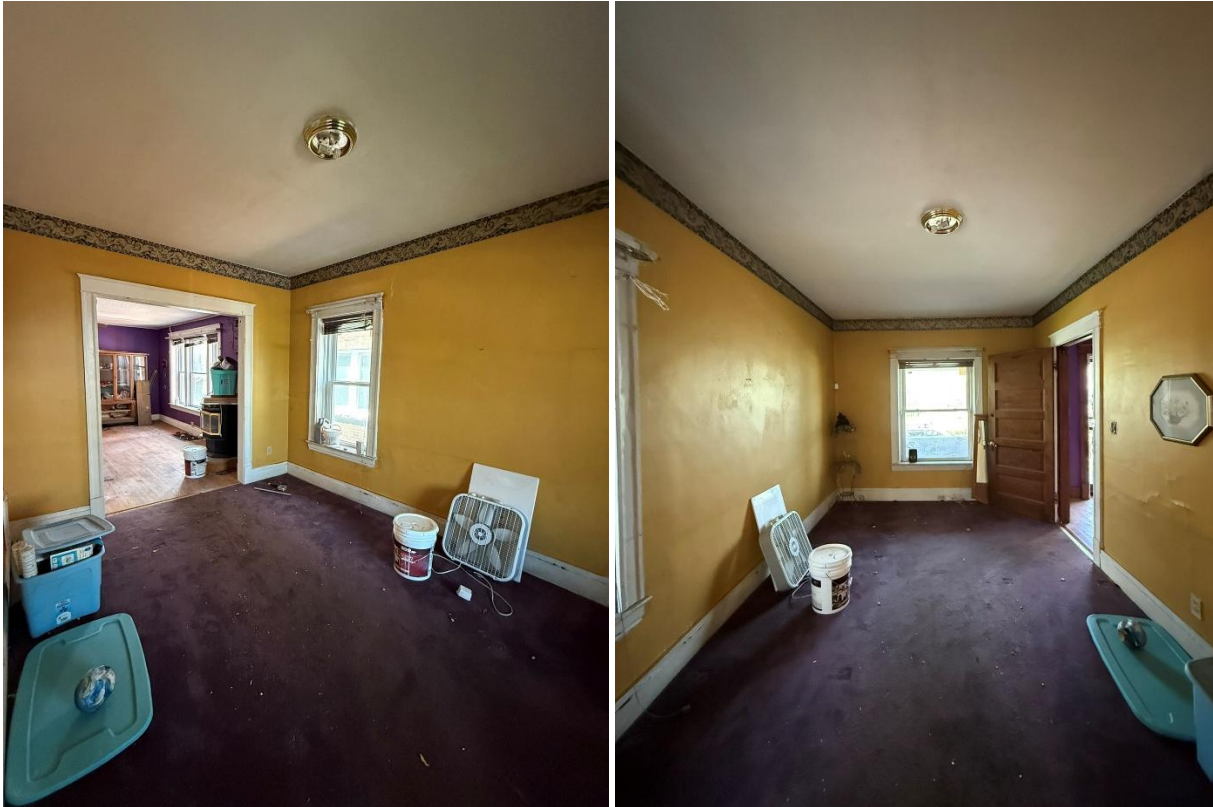
#### 4. Middle Room

**Dimensions: 16'5" x 18'**

- Demo existing ceiling.
- Install new 5/8 inch drywall ceiling; tape, mud, sand smooth, and finish paint-ready.
- Repair damaged wall areas.
- Sand and refinish hardwood flooring.
- Consult PBN for stain selection and apply three coats clear polyurethane.
- Replace existing light fixture.
- Repair plaster in closet and paint closet interior.
- Paint walls, ceiling, and trim.

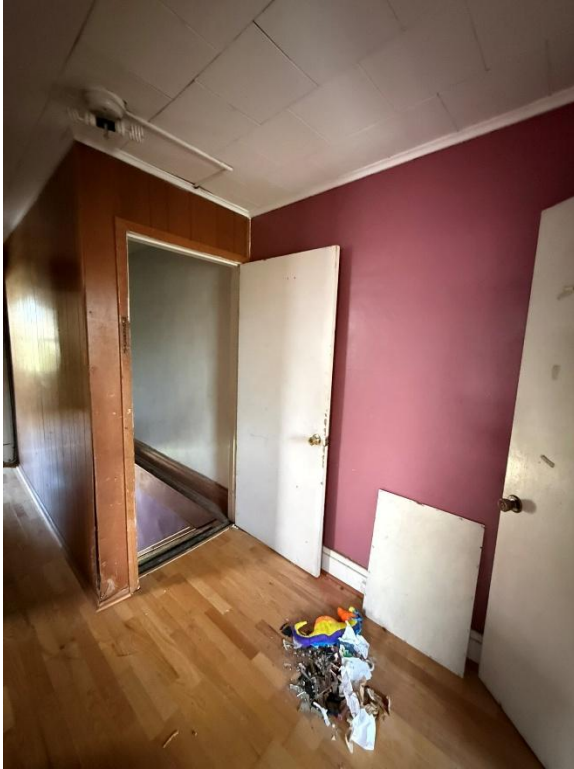
## 10. Hallway

**Dimensions: 9'5" x 3'**

- Preserve existing flooring.
- Replace existing light fixture.
- Minor wall and trim repair.
- Paint walls and ceiling.

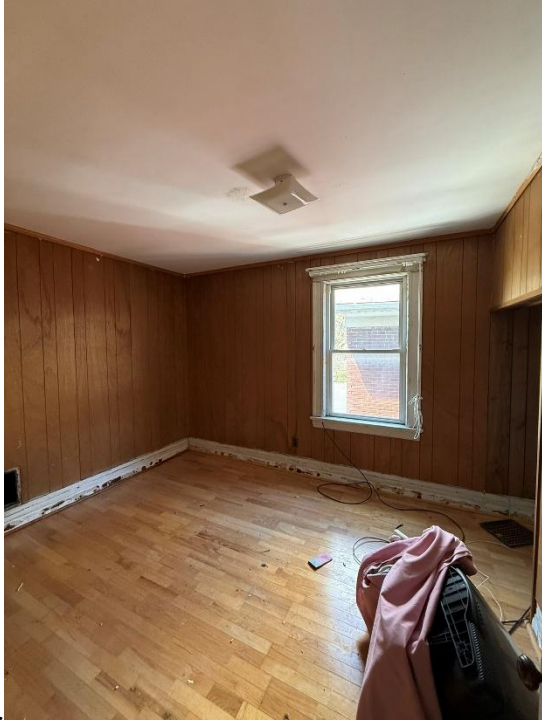
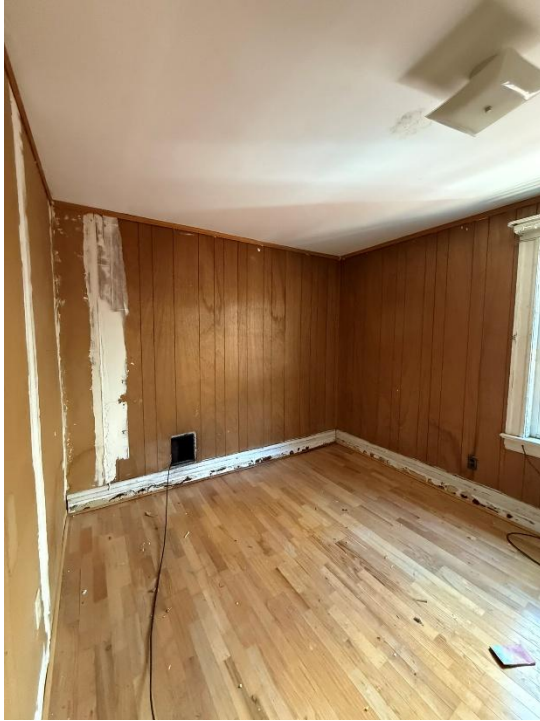
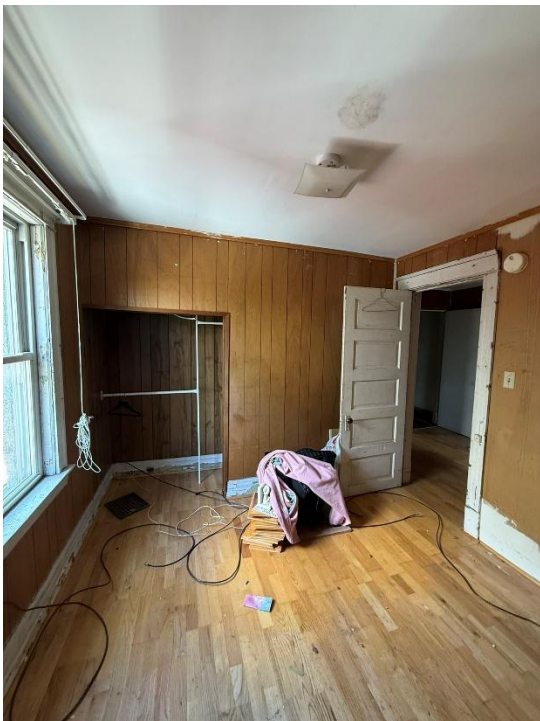
### 13. Bedroom 2

**Dimensions: 9'5" x 10'9"**

- Demo existing ceiling and install new drywall.
- Demo existing wall surfaces and install new drywall.
- Remove carpet and assess hardwood condition.
- Refinish hardwood if suitable or install vinyl plank flooring.
- Replace existing light fixture.
- Bid both flooring options with per-SF pricing.

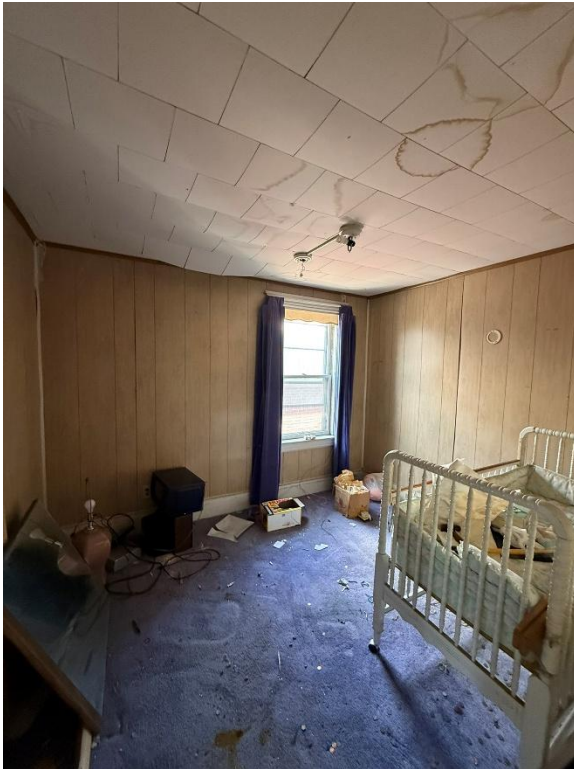
### 14. Bedroom 3

**Dimensions: 9'4" x 13'1"**

- Remove existing wallboard and install new drywall.
- Tape, mud, sand, and finish paint-ready.
- Replace existing light fixture.
- Repair damaged window screens throughout apartment.
- Remove closet carpet and paint closet interior.

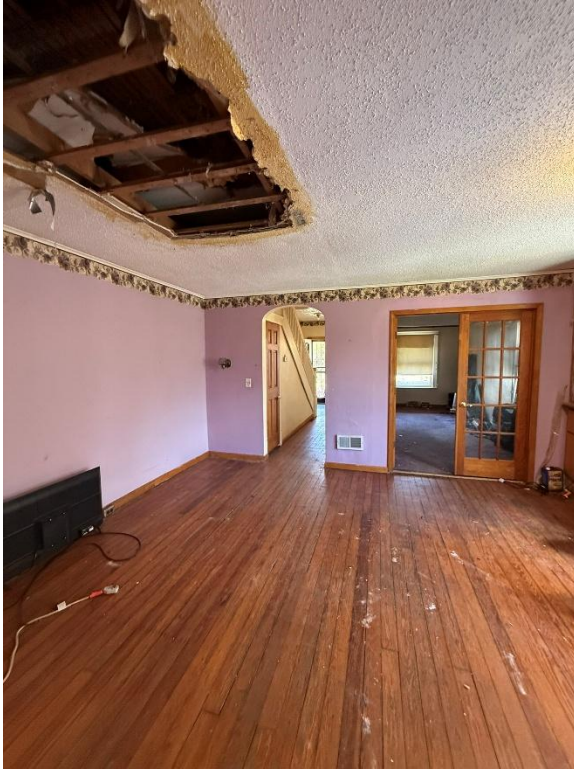
## 5. Front Room

**Dimensions: 9'10" x 18'11"**

- Remove carpet.
- Refinish hardwood if condition permits or install vinyl plank flooring.
- Paint walls and ceiling.
- Bid both flooring options with per-SF pricing.

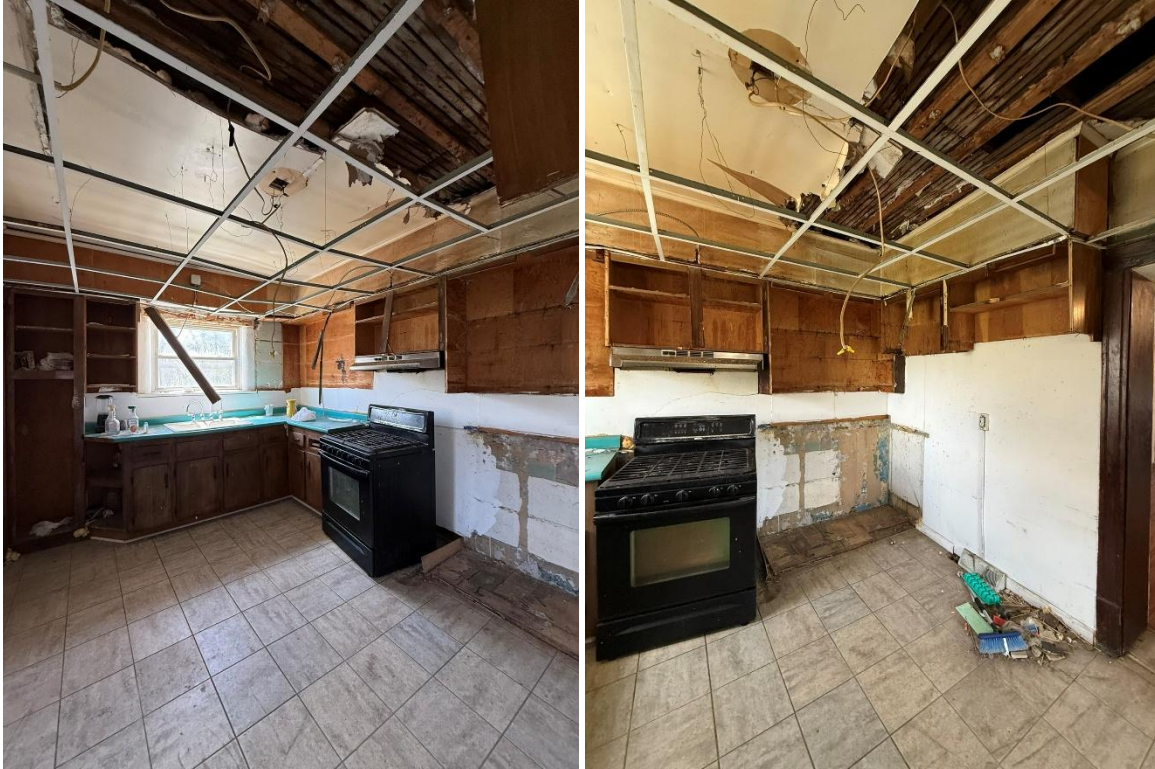
## 7. Kitchen Nook

**Dimensions: 8' x 7'**

- Remove existing cabinets and flooring.
- Install new flooring per PBN material selection.
- Supply and install light fixture.
- Verify all outlets are code compliant.

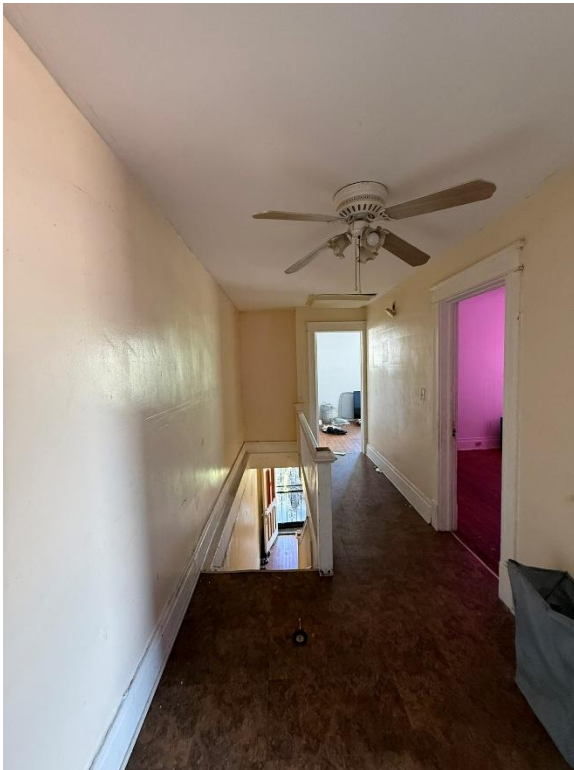
## 11. Hall

**Dimensions: 9'10" x 3'5"**

- Remove and replace ceiling hatch.

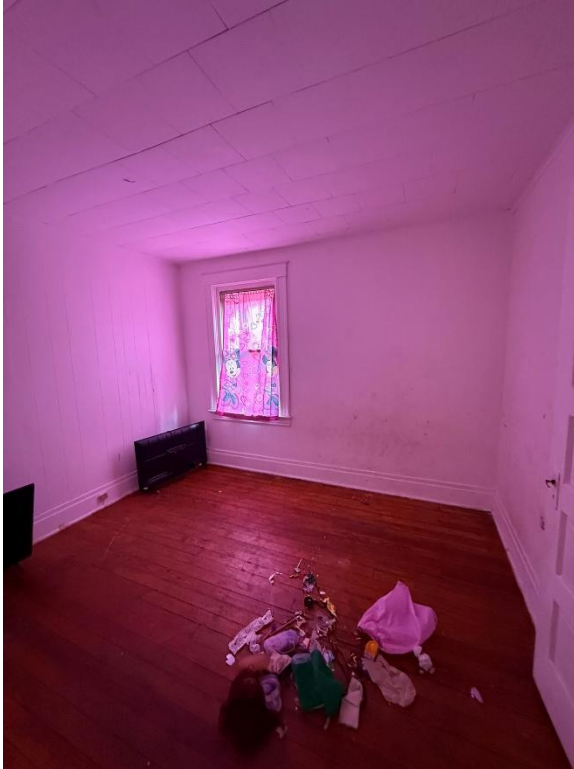
### 13. Front Bedroom

**Dimensions: 9'4" x 13'3"**

- Repair wall cracks and prep for paint.
- Remove and replace damaged ceiling tiles.
- Complete pest/rodent remediation prior to finish work.
- Refinish hardwood flooring.
- Consult PBN for stain selection.
- Supply and install wall light fixture.
- Paint walls and ceiling.
